October 2, 2020

**Re: Restoration of S.E.A. District Water Features (E16458)
City of Corpus Christi
Feasibility MSA (Bond 2020)
City Contract No. 2853
LNV Project No. 180340.040
Task Order #4 – Letter Report: In Place Water Gardens Fountain Repairs**

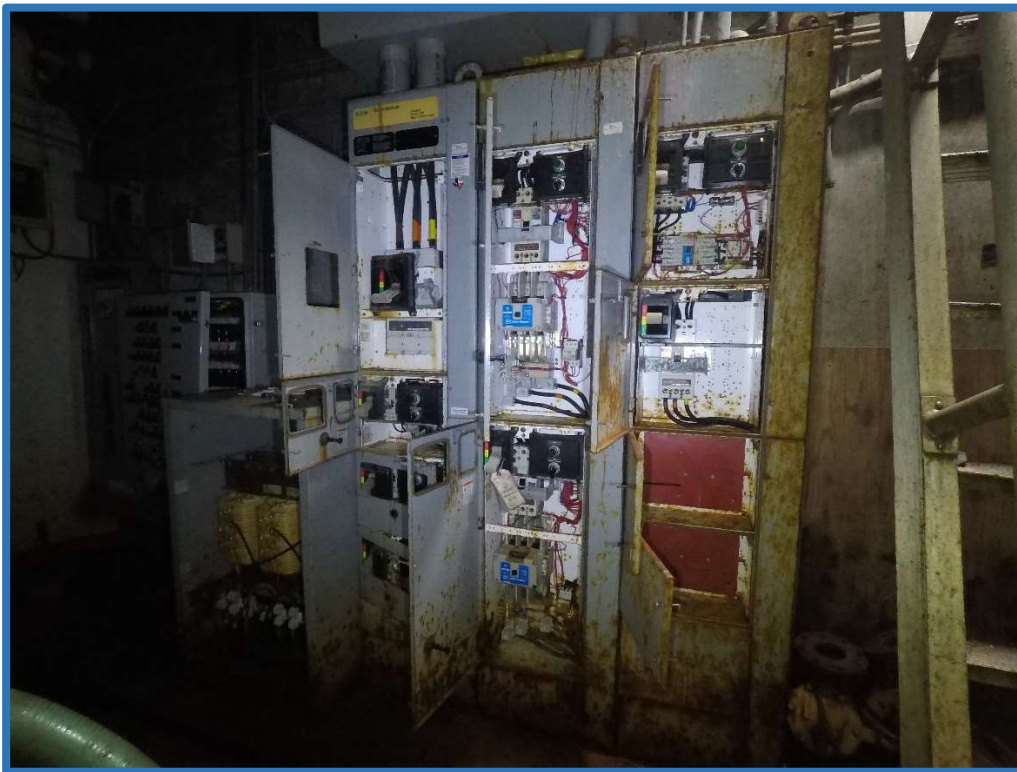
1. The underground vault has essentially been under water continuously for the past two (2) years. All equipment and electrical controls are corroded and beyond repair and must be removed and replaced. The pictures below illustrate the water damage and corrosion of equipment on February 8, 2018.

Electrical Control Panel – Corrosion Indicates Water Level

5. All the electrical controls for the fountain are currently located in the underground vault. Given the highly humid environment of the vault and the potential for flooding, all the new electrical equipment and controls must be located outside of the vault and in an elevated, electrical control building. The depth of water during a 100-year flood event in the fountain area is estimated to be three (3) feet above natural ground per FEMA. As such, the finish floor elevation of the new electrical control building must be a minimum of four (4) feet above natural ground. In addition to the electrical controls, all chemicals and chemical treatment equipment must be located outside of the vault. Removal of hazardous chemicals from the vault will reduce the severity of the confined space characteristics of the underground vault and improve the safety to personnel entering vault. The chemicals

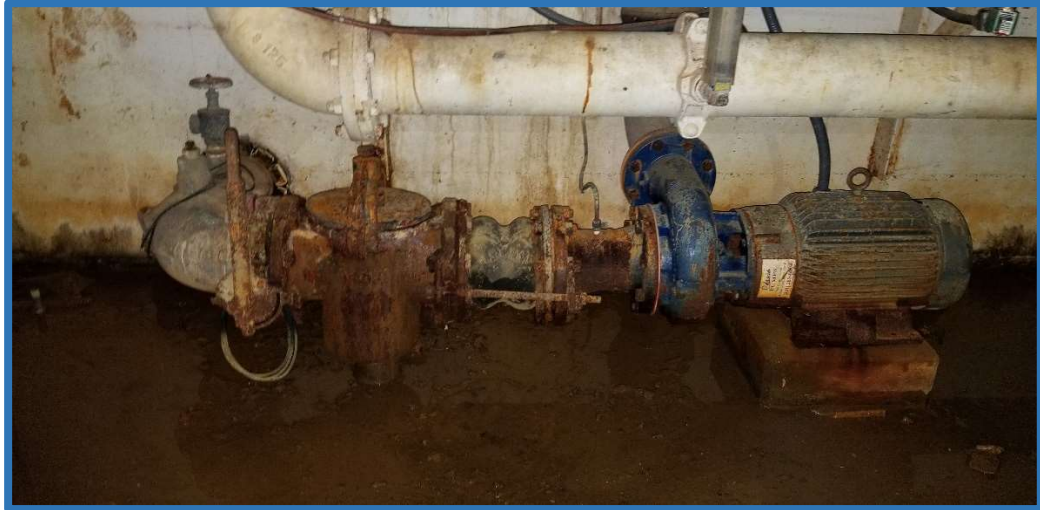
Corroded Sand Filter Pump

4. As stated in Item 1 above, all existing equipment in the underground vault is damaged beyond repair and must be removed and replaced with new equipment. In order to re-use the existing underground vault, the type of pumps and pump configuration must remain the same. This means the replacement pumps must be split case pumps and pump redundancy cannot be incorporated into the vault repairs. Split case pumps are known to be more expensive, less reliable, and have a higher O&M cost than other pump options such as submersible pumps. Lack of redundancy means that after repairs are made and the fountain is running again, the fountain will go down if any of the pumps fail and will remain down until the pump can be repaired or replaced. In addition to the new pumps, new equipment to be installed in the vault will include a sand filter, mechanical and electrically controlled valves, solenoids, and a UV sterilizer. It is anticipated that the new equipment will not take up as much space as the existing equipment, which will allow space for creation of personnel safety features such as eye wash and emergency shower stations.

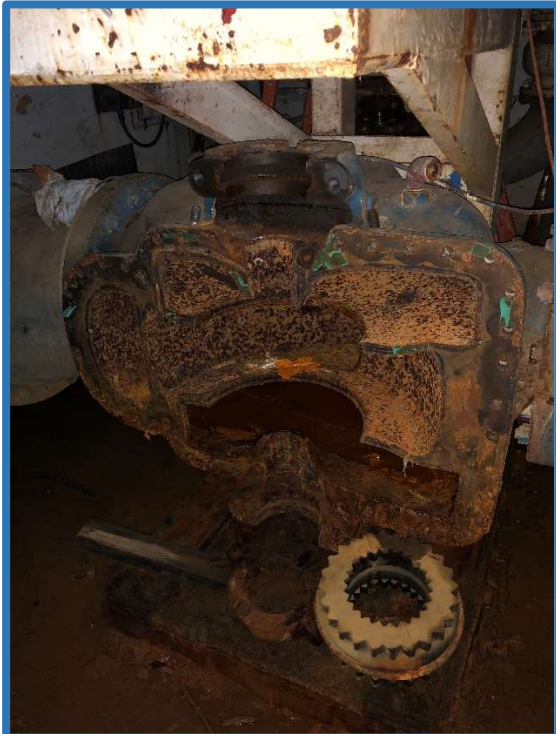
Corroded Main Display Pump

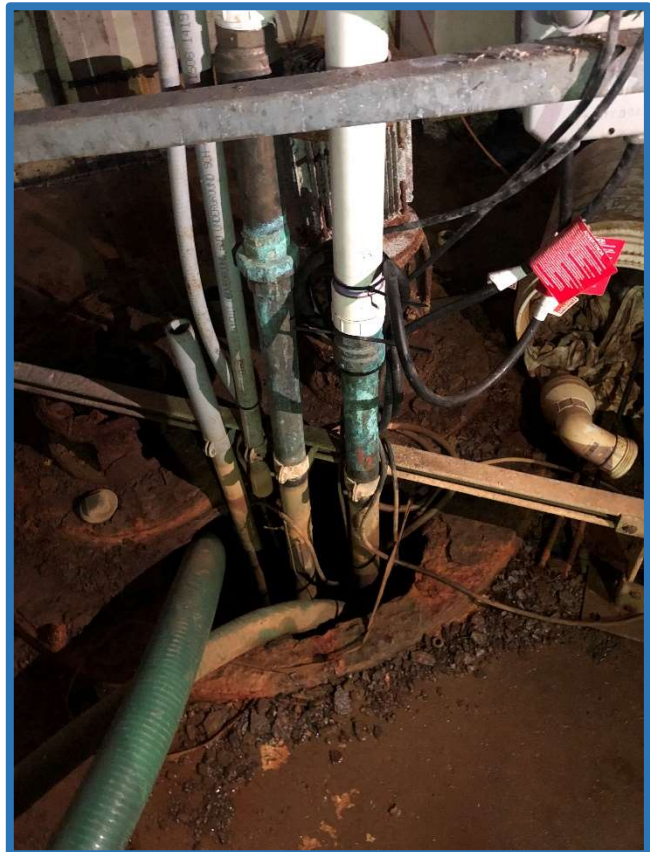
Corroded Vault Sump (*)

(* The sump has been demolished since this picture in an attempt to identify and stop the inflow of water into the sump.)

3. Failure of the sump pumps to keep up with incoming flood waters is a significant factor, if not the major source, of past vault flooding. Either the pump electrical controls were shorted due to incoming water, preventing the pumps from running, or the pumps did not have the capacity to keep up with incoming flood water, which ultimately lead to water reaching the electrical controls and causing a short. Once the sump pumps stopped working, the vault would flood, inundating all the equipment. To try and prevent future flooding, the existing sump should be demolished and replaced with a new, larger sump. Duplex submersible pumps should be incorporated into the new sump, and the new pumps should be sized to individually handle a worst-case flooding event. Construction of the new sump should occur after sources of infiltration have been identified and eliminated and before waterproofing measures are employed in the vault. Electrical controls that operate the sump pumps must be located outside of the vault in a new, above-ground electrical control building. It should be noted that, because the vault is underground, the threat of potential flooding cannot be completely removed.

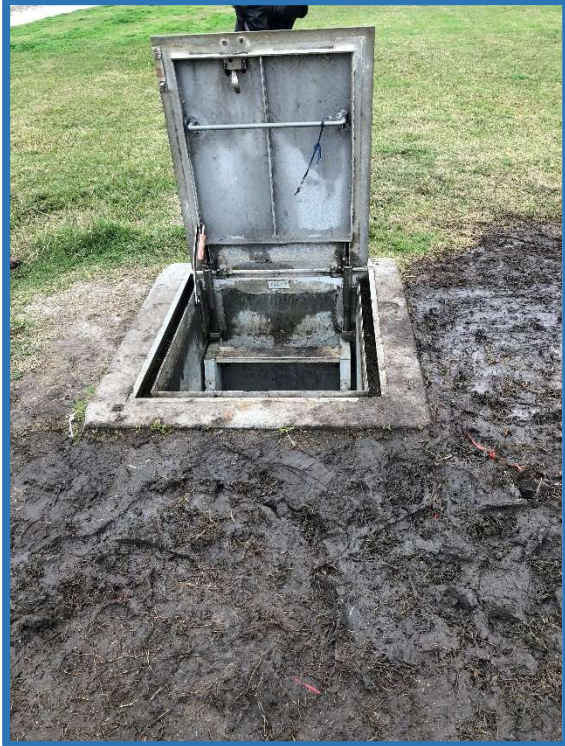
7. As previously mentioned, access to the underground vault is extremely limited. Personnel must enter the vault using a metal hatch at ground level and a steep ladder down to the floor of the vault. Access to equipment can only occur through the large, concrete hatch in the vault roof, which must be first excavated and then removed using large equipment. (See pictures on the following page.) One of the defining characteristics of a "confined space" is limited access. Although it is not possible to remove the classification of the vault as a "confined space", because it is underground with only one access point, access to the vault for both personnel and equipment should be improved. The personnel access should be improved to include stairs down to the vault. The stairs should be wide enough for two (2) people to access simultaneously. The extra width to the stairs will also allow personnel to carry large tools, or equipment, into the vault. A double-door, ground level hatch could be used to access the stairs if the hatch were waterproof. Another option would be to have the stairs exit onto an elevated, concrete foundation with a finish floor elevation at least four (4) feet above natural ground. A previous suggestion for an improvement to the Water Gardens area was to add a bandstand for outdoor concerts. An elevated bandstand could serve as an exit for the stairs that is above the elevation of the 100-year flood waters. To improve access to equipment for maintenance and removal/installation, a concrete collar should be constructed around the hole in the vault roof and extended to the surface. A double-door, ground level hatch could be installed at ground level. This improvement will eliminate the need to employ excavation equipment to access equipment in the vault. Large equipment will still be required to remove/install equipment in the vault. The ground level hatch must be waterproof to prevent stormwater runoff from entering the vault.

Ground Level Personnel Hatch

2. Once all the equipment has been removed from the vault, the vault must be thoroughly cleaned and investigated for sources of infiltration. (Note: An asbestos survey of the vault has been performed, and no sources of asbestos were observed in the vault.) Excavation around the outer perimeter of the vault may be required in order to determine the source, or sources, of water infiltration. Identified sources of infiltration must be remedied. All excavations must be properly backfilled and restored to existing grades. The walls, floor and ceiling of the vault must be coated with an appropriate waterproofing membrane. The large, equipment access hatch in the vault roof must be waterproofed. The metal, personnel hatch must be replaced with a waterproof accessway.

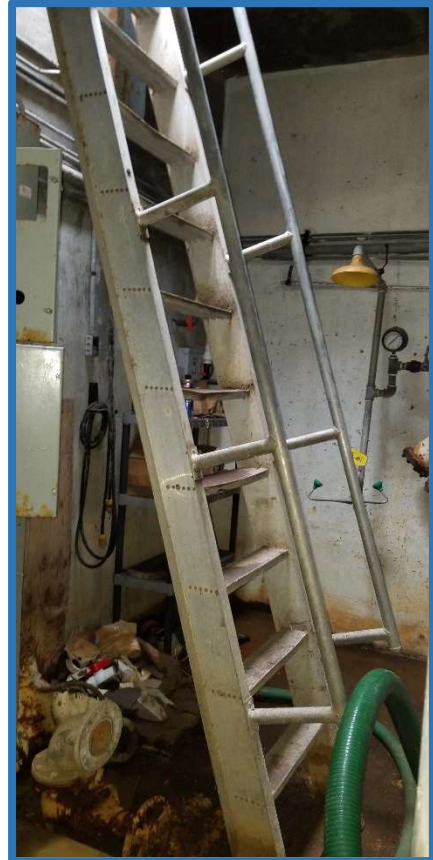
Ladder to Vault Floor

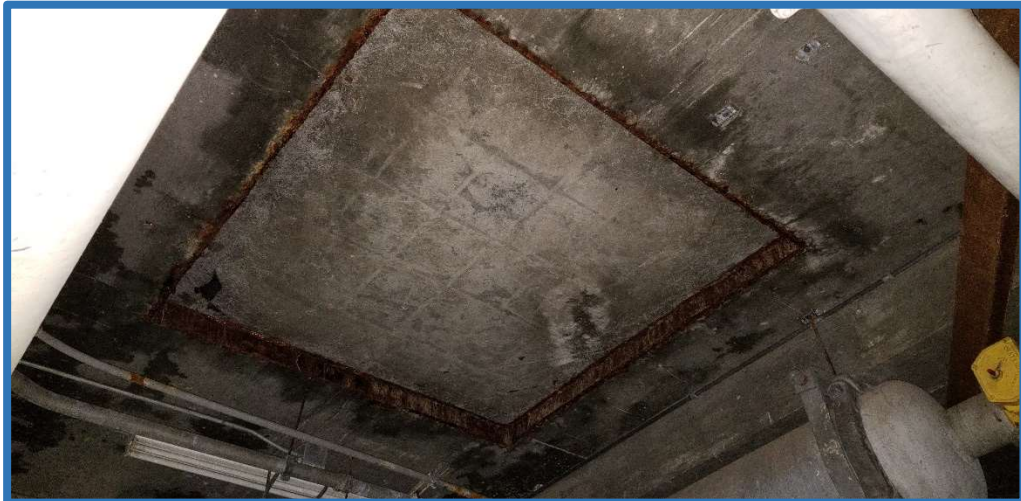
Concrete Equipment Hatch in Vault Roof
