# SAFETY ADVISORY

Fire Fighter Fatality Investigation and Prevention Program

## Improper Set-up of Aerial Ladders with a Locking Waterway May Put Fire Fighters at Risk

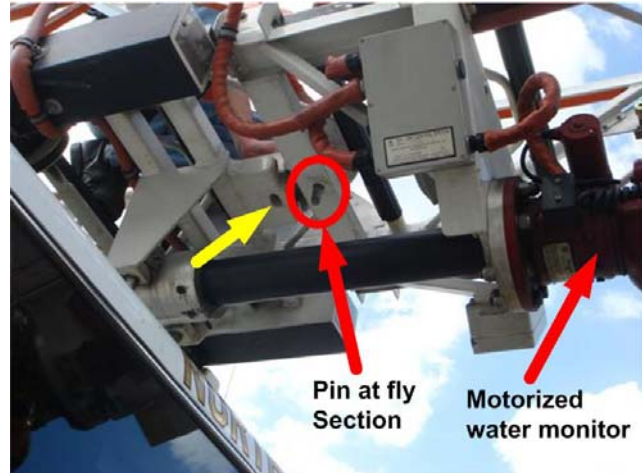
Photo 1 - A properly seated pin at the fly section for defensive water stream operations is highlighted in the red circle. The hole behind it (yellow arrow) shows the location where the pin would be inserted (from the top) to keep the monitor assembly back at the second ladder section for rescue mode. **NOTE:** Various methods are used throughout the fire apparatus industry to secure the waterway: this picture represents a pin-anchored waterway design.

- **Ensure that Standard Operating Procedures (SOPs) and/or Guidelines (SOGs) on setting up multi-position waterways include steps to properly position the waterway and to inspect and verify that the locking mechanism (anchoring pin(s), lever, clamps, etc.) are properly installed and functioning as designed before pressurizing the waterway.**
- **Properly train and practice the correct method of securing waterways and verifying they are secured (per manufacturer's recommendations).**

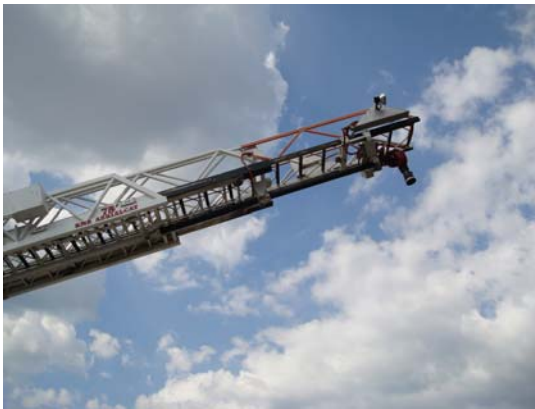
Photo 2 – Aerial ladder with monitor at tip

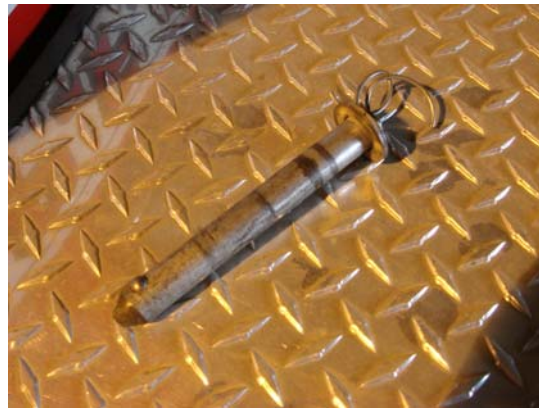
Photo 3 – anchoring pin

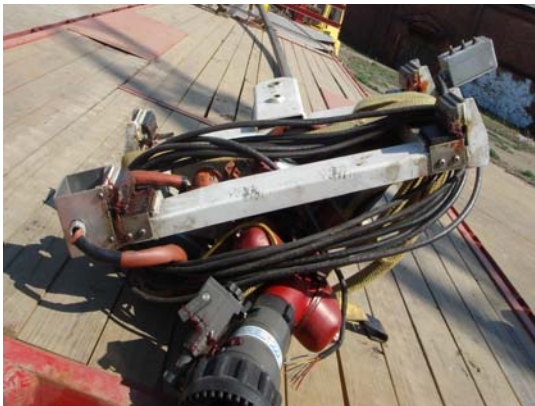
On April 8, 2008, a volunteer Deputy Fire Chief (the Incident Commander), was killed when struck by a motorized water monitor and 30 feet of aluminum pipe that was “launched” off an elevated aerial ladder at a fire at an industrial manufacturing plant in Pennsylvania. The truck was normally transported in the “rescue mode” with the monitor pinned to the second section of ladder so that the waterway would not be in the way if the ladder was set up for rescue operations. At the incident scene, when the waterway was pressurized, the monitor and its support bracket, along with the last 30-foot section of pipe were “launched” off the aerial ladder by the force of the water pressure in the pipe. The monitor flew approximately 75 feet and fell, striking the Incident Commander on the head, killing him instantly. After the incident, the anchor pin was found on the ground, in front of the truck’s cab. The waterway did not include any secondary mechanical stops to prevent the separation of the water monitor in the event the anchoring pin was not properly seated. The NIOSH Fire Fighter Fatality Investigation and Prevention Program is currently investigating this incident and a full report will be available at a later date.

Photo 4 – Monitor and pipe that “launched”

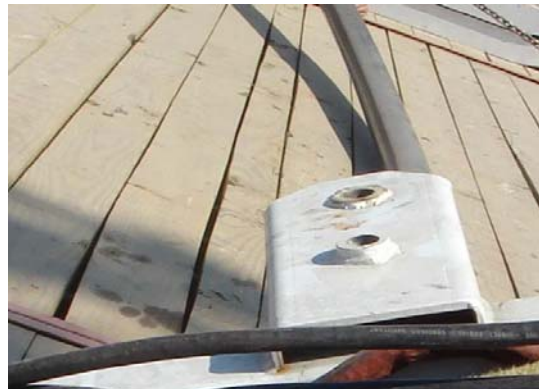
Photo 5 - The receiver assembly where the pin is inserted
